LA-UR-21-20541

Title: An Investigation of Critical Pit Size in SAVY 4000 Wall

Tristan Karns, John Davis, Jonathan Gigax, David Grow, Jude Oka, Daniel Rios,
Jonathan Teague, Rajendra U. Vaidya

Nuclear Process Infrastructure, Los Alamos National Laboratory, Los Alamos, NM

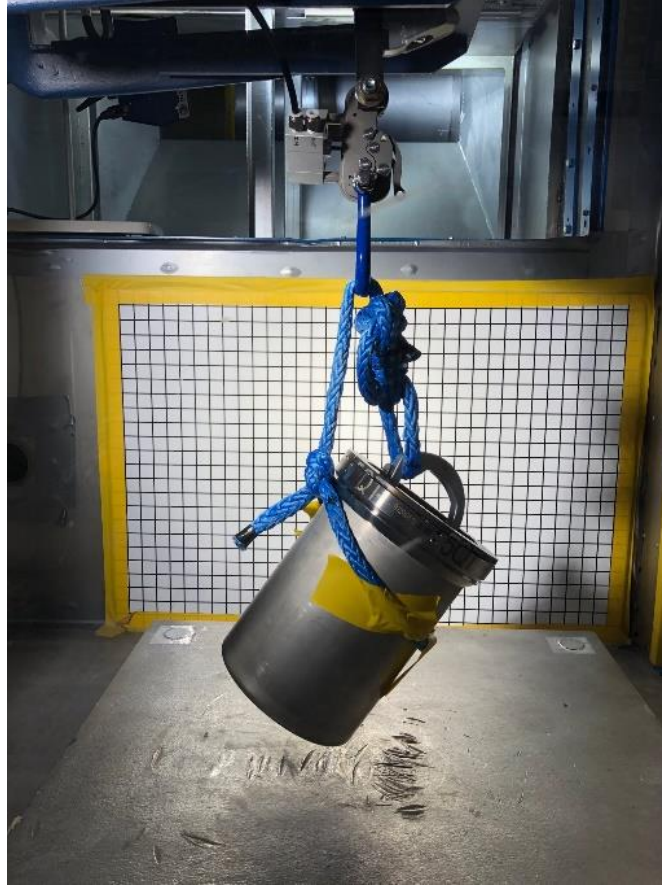
FIGURE 2 DEGRADED CONTAINER HANGING IN FINAL DROP ORIENTATION FROM SLING SYSTEM

The drop test was performed in a drop tower that is equipped with an essentially unyielding floor. The drop tower is capable of dropping from a maximum height of 15 feet 8 inches using a swing away drop leaf or ~13 feet 8 inches using a sling system with a pneumatic release (Figure 2). The drop tower was designed to allow containers loaded with a surrogate material (e.g., cerium oxide) to be dropped and have the particulate release measured using aerosol particle counters. The test performed on the pitted 5 quart SAVY container did not contain any surrogate material, and the test was setup to mimic the qualification drop test, e.g. drop orientation, gross weight and height.

The degraded container was dropped from 12 feet using the sling system with pneumatic release. The container's gross weight was 18.3742 kg and was drop center of gravity (CG) over bottom corner (Figure 2). The orientation was chosen to maximize plastic deformations on the container body thus inducing the highest amount of stresses in the container body.

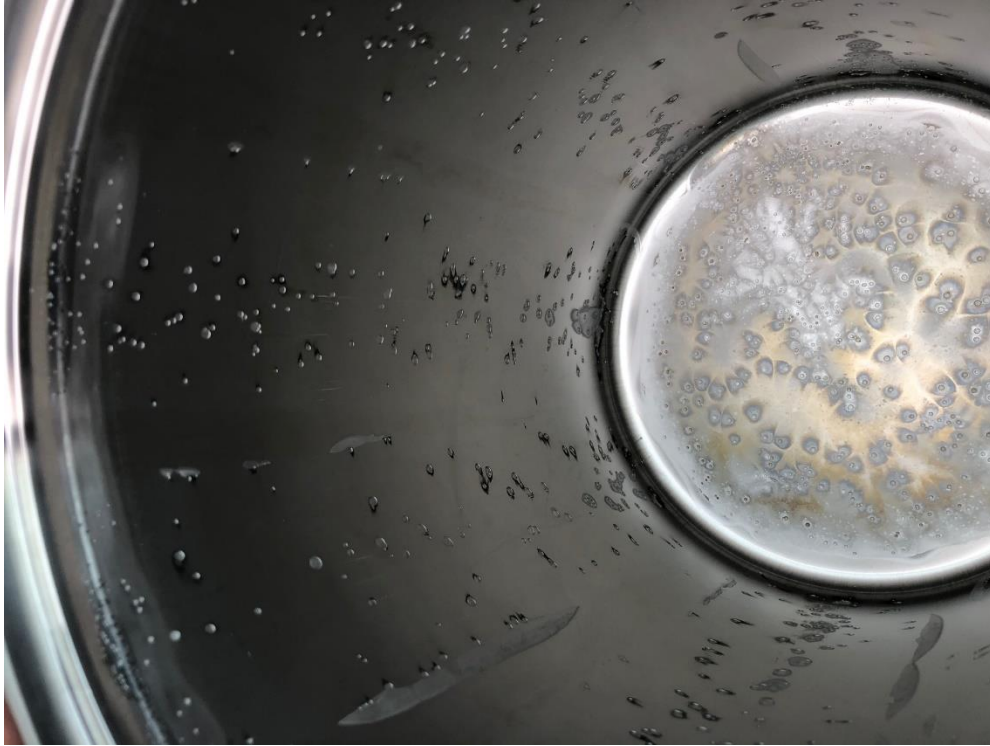
FIGURE 9 INNER SURFACES OF WHOLE SAVY AFTER BEING PITTED.

completely corroded (Figure 9) the eddy current instrument on the MINTS was used to measure the pit depths. The MINTS showed that the pits were between 35% and 55%, confirming that the container was in the range that was desired.

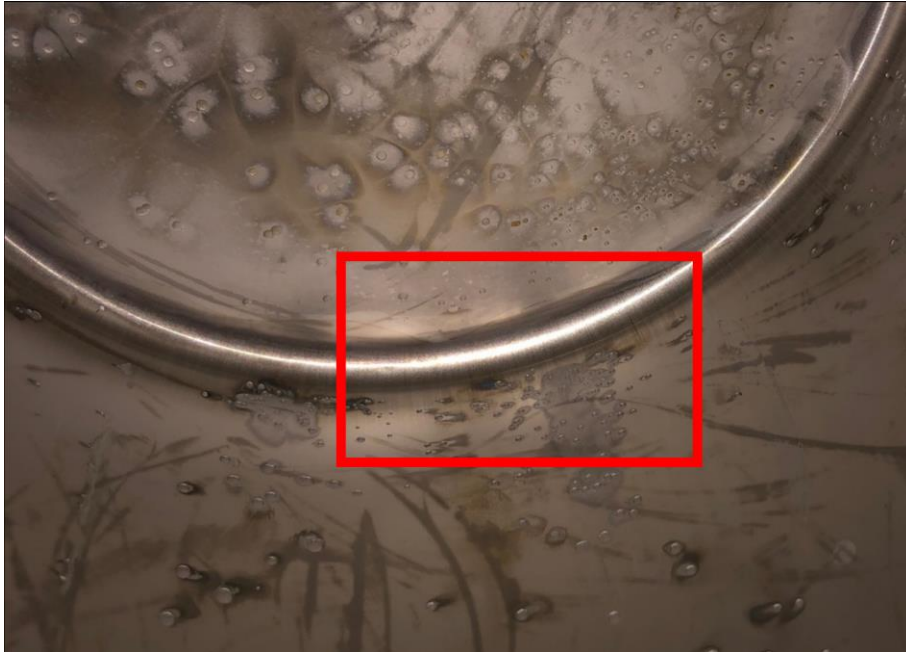
FIGURE 10 CORRODED REGION INSIDE OF SAVY WITH THE HIGHEST DENSITY OF PITS.

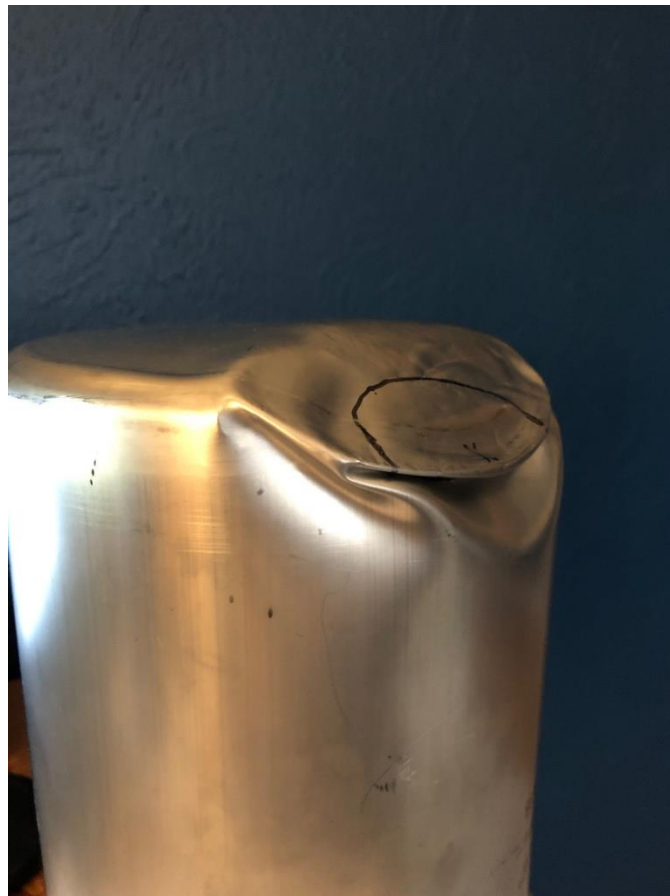
FIGURE 11 DAMAGE POST-DROP TEST WITH BLACK "X" INDICATING TARGET REGION.

The helium leak tester in PF-4 was used on the corroded SAVY container before it was loaded with the payload in order to get a pre-drop helium leak rate and to ensure that none of the pits that were generated corroded through the thickness of the container. The pre-drop He leak rate was 7.9×10^{-8} atm cc/sec. The container was then taken to the drop tower at TA-03 Building 130. The container was visually inspected to identify the inner bottom radius region with the highest density of pitting which was the target impact location (Figure 10). The payload was made up to be 15.0178 kg bringing the total gross weight of the corroded container to 18.3742 kg. The loaded corroded container was then rigged in a sling and hung by the drop mechanism as was seen in Figure 2. The container was dropped from 12 feet and there was no evidence of failure (Figure 11). The container was removed from the drop tower and the payload was removed from the dropped container. A post-drop helium leak rate was obtained by taking the now empty SAVY back to PF-4. The helium leak rate was recorded as 1.2×10^{-7} atm cc/sec. There was a 51.9% increase in helium leak rate between the pre and post drop rates. The increased helium leak rate can likely be explained by an increase in background helium in the system before the leak rate was measured. The background helium had a 191.2% increase in background from pre to post helium leak rate measurements.
